Channel Change on the Santa Cruz River, Pima County, Arizona, 1936–86

By JOHN T.C. PARKER

U.S. GEOLOGICAL SURVEY
Open-File Report 93—41

Prepared in cooperation with the
PIMA COUNTY DEPARTMENT OF TRANSPORTATION
AND FLOOD CONTROL DISTRICT

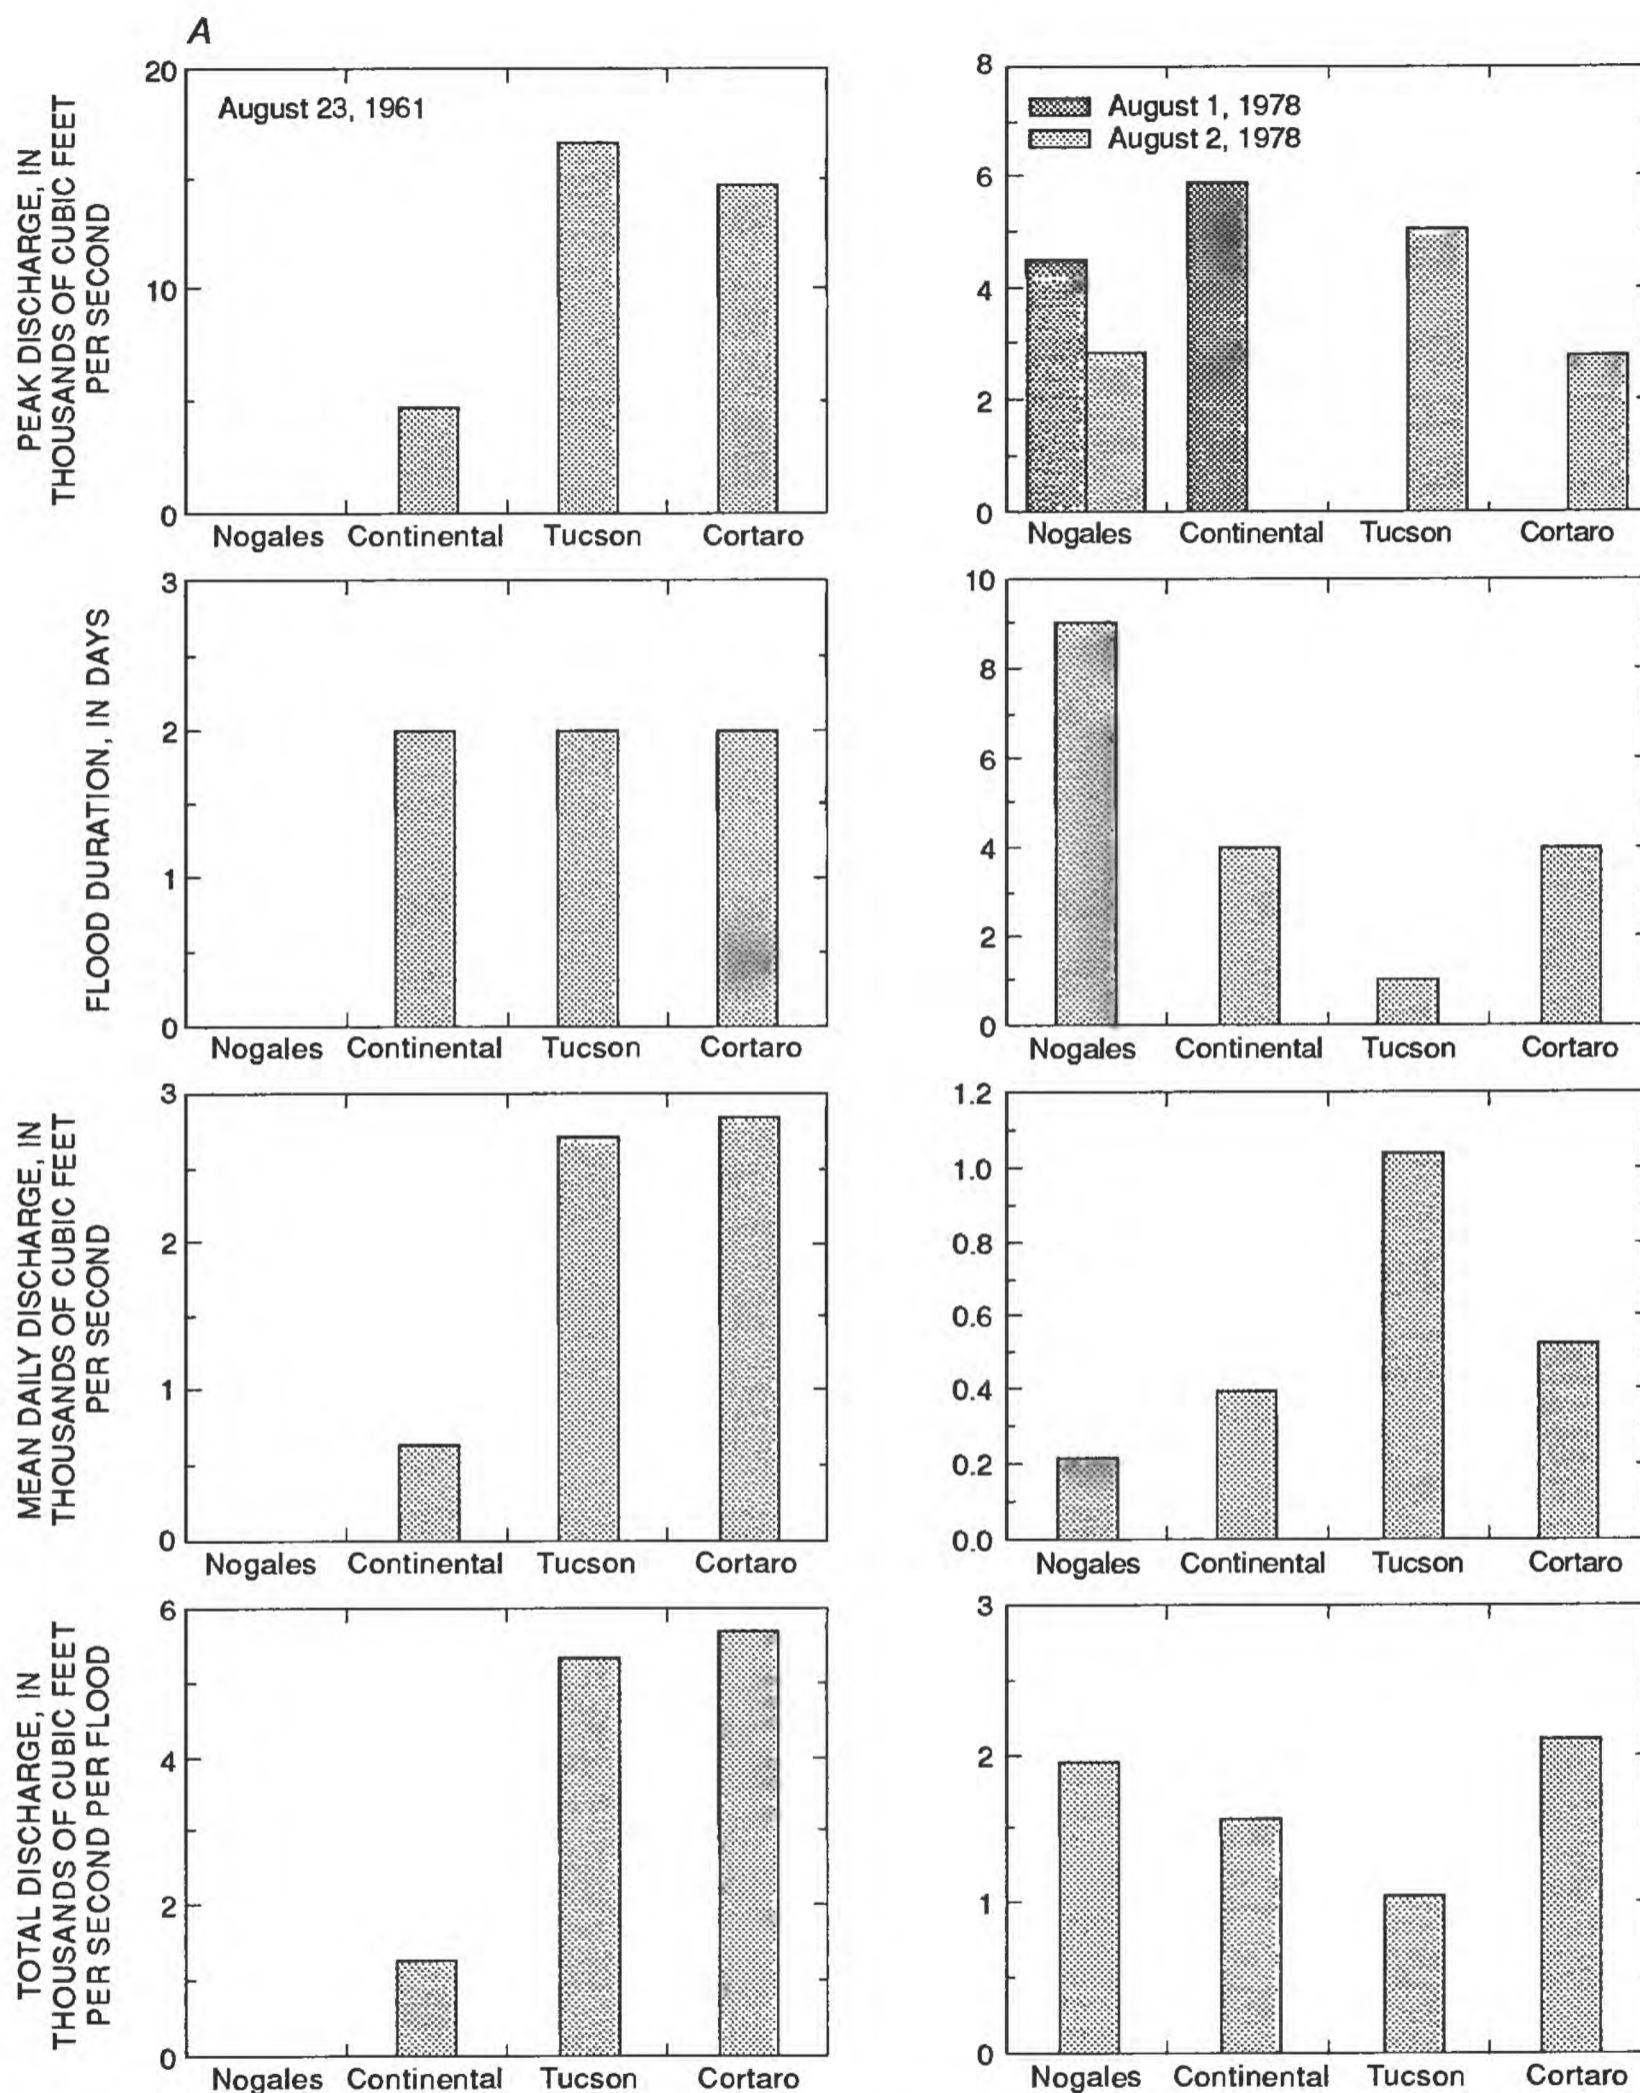
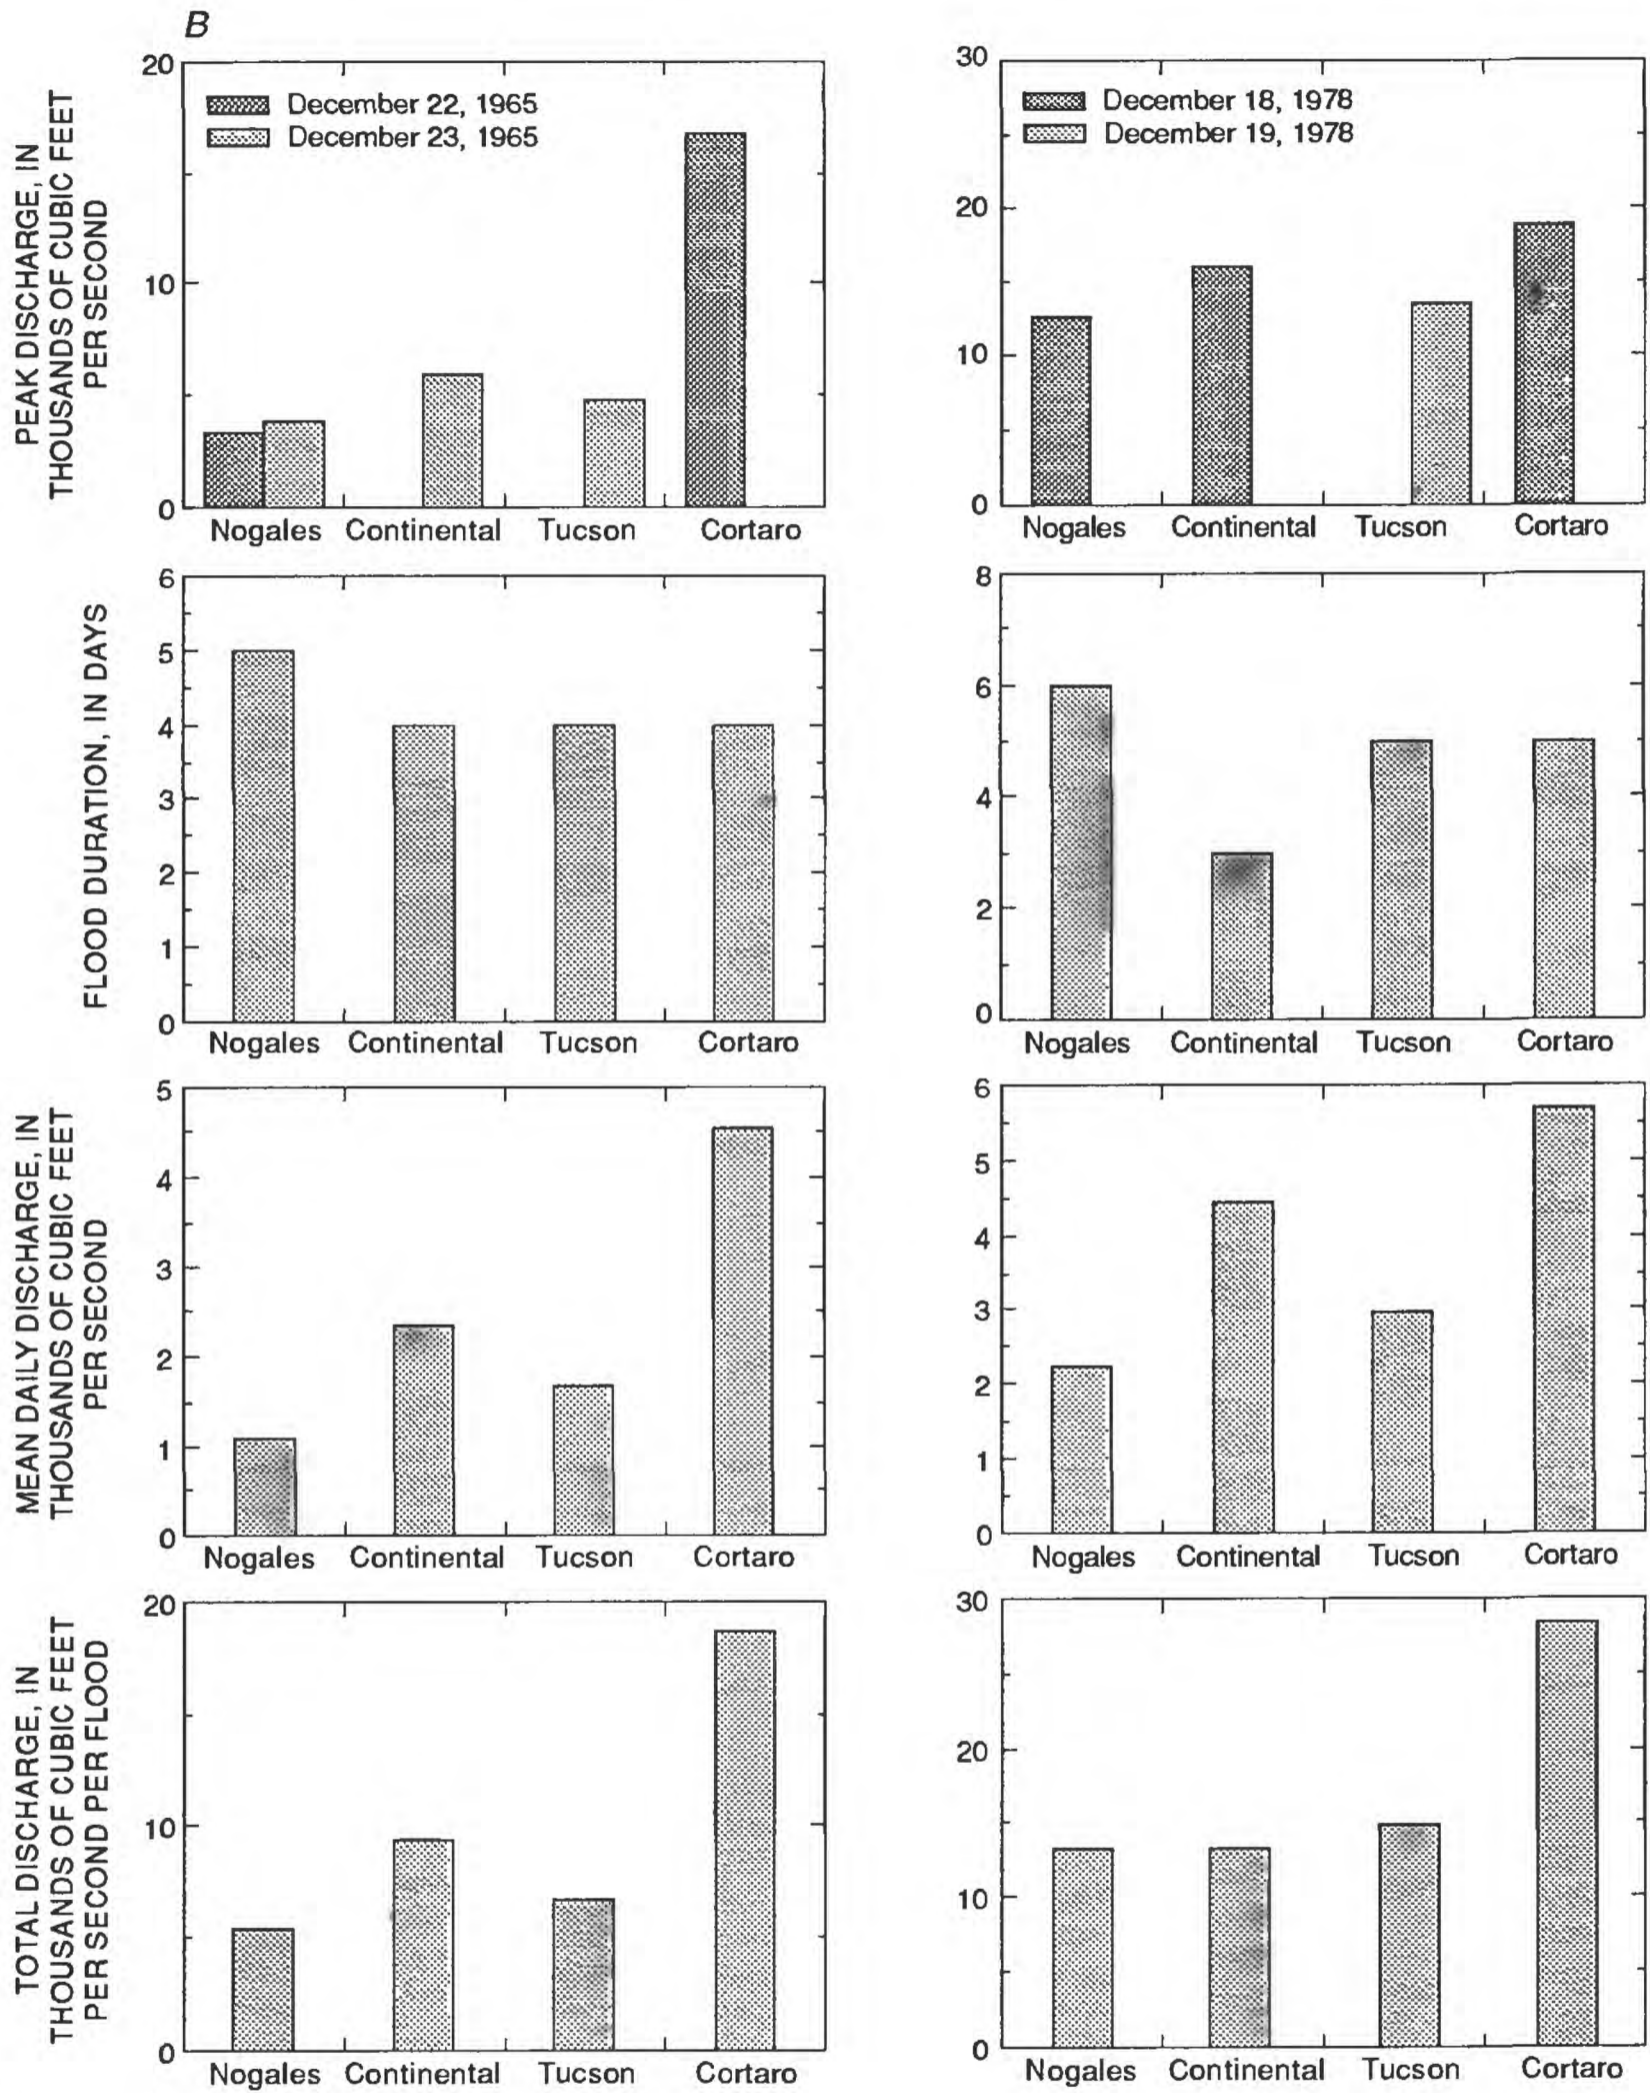
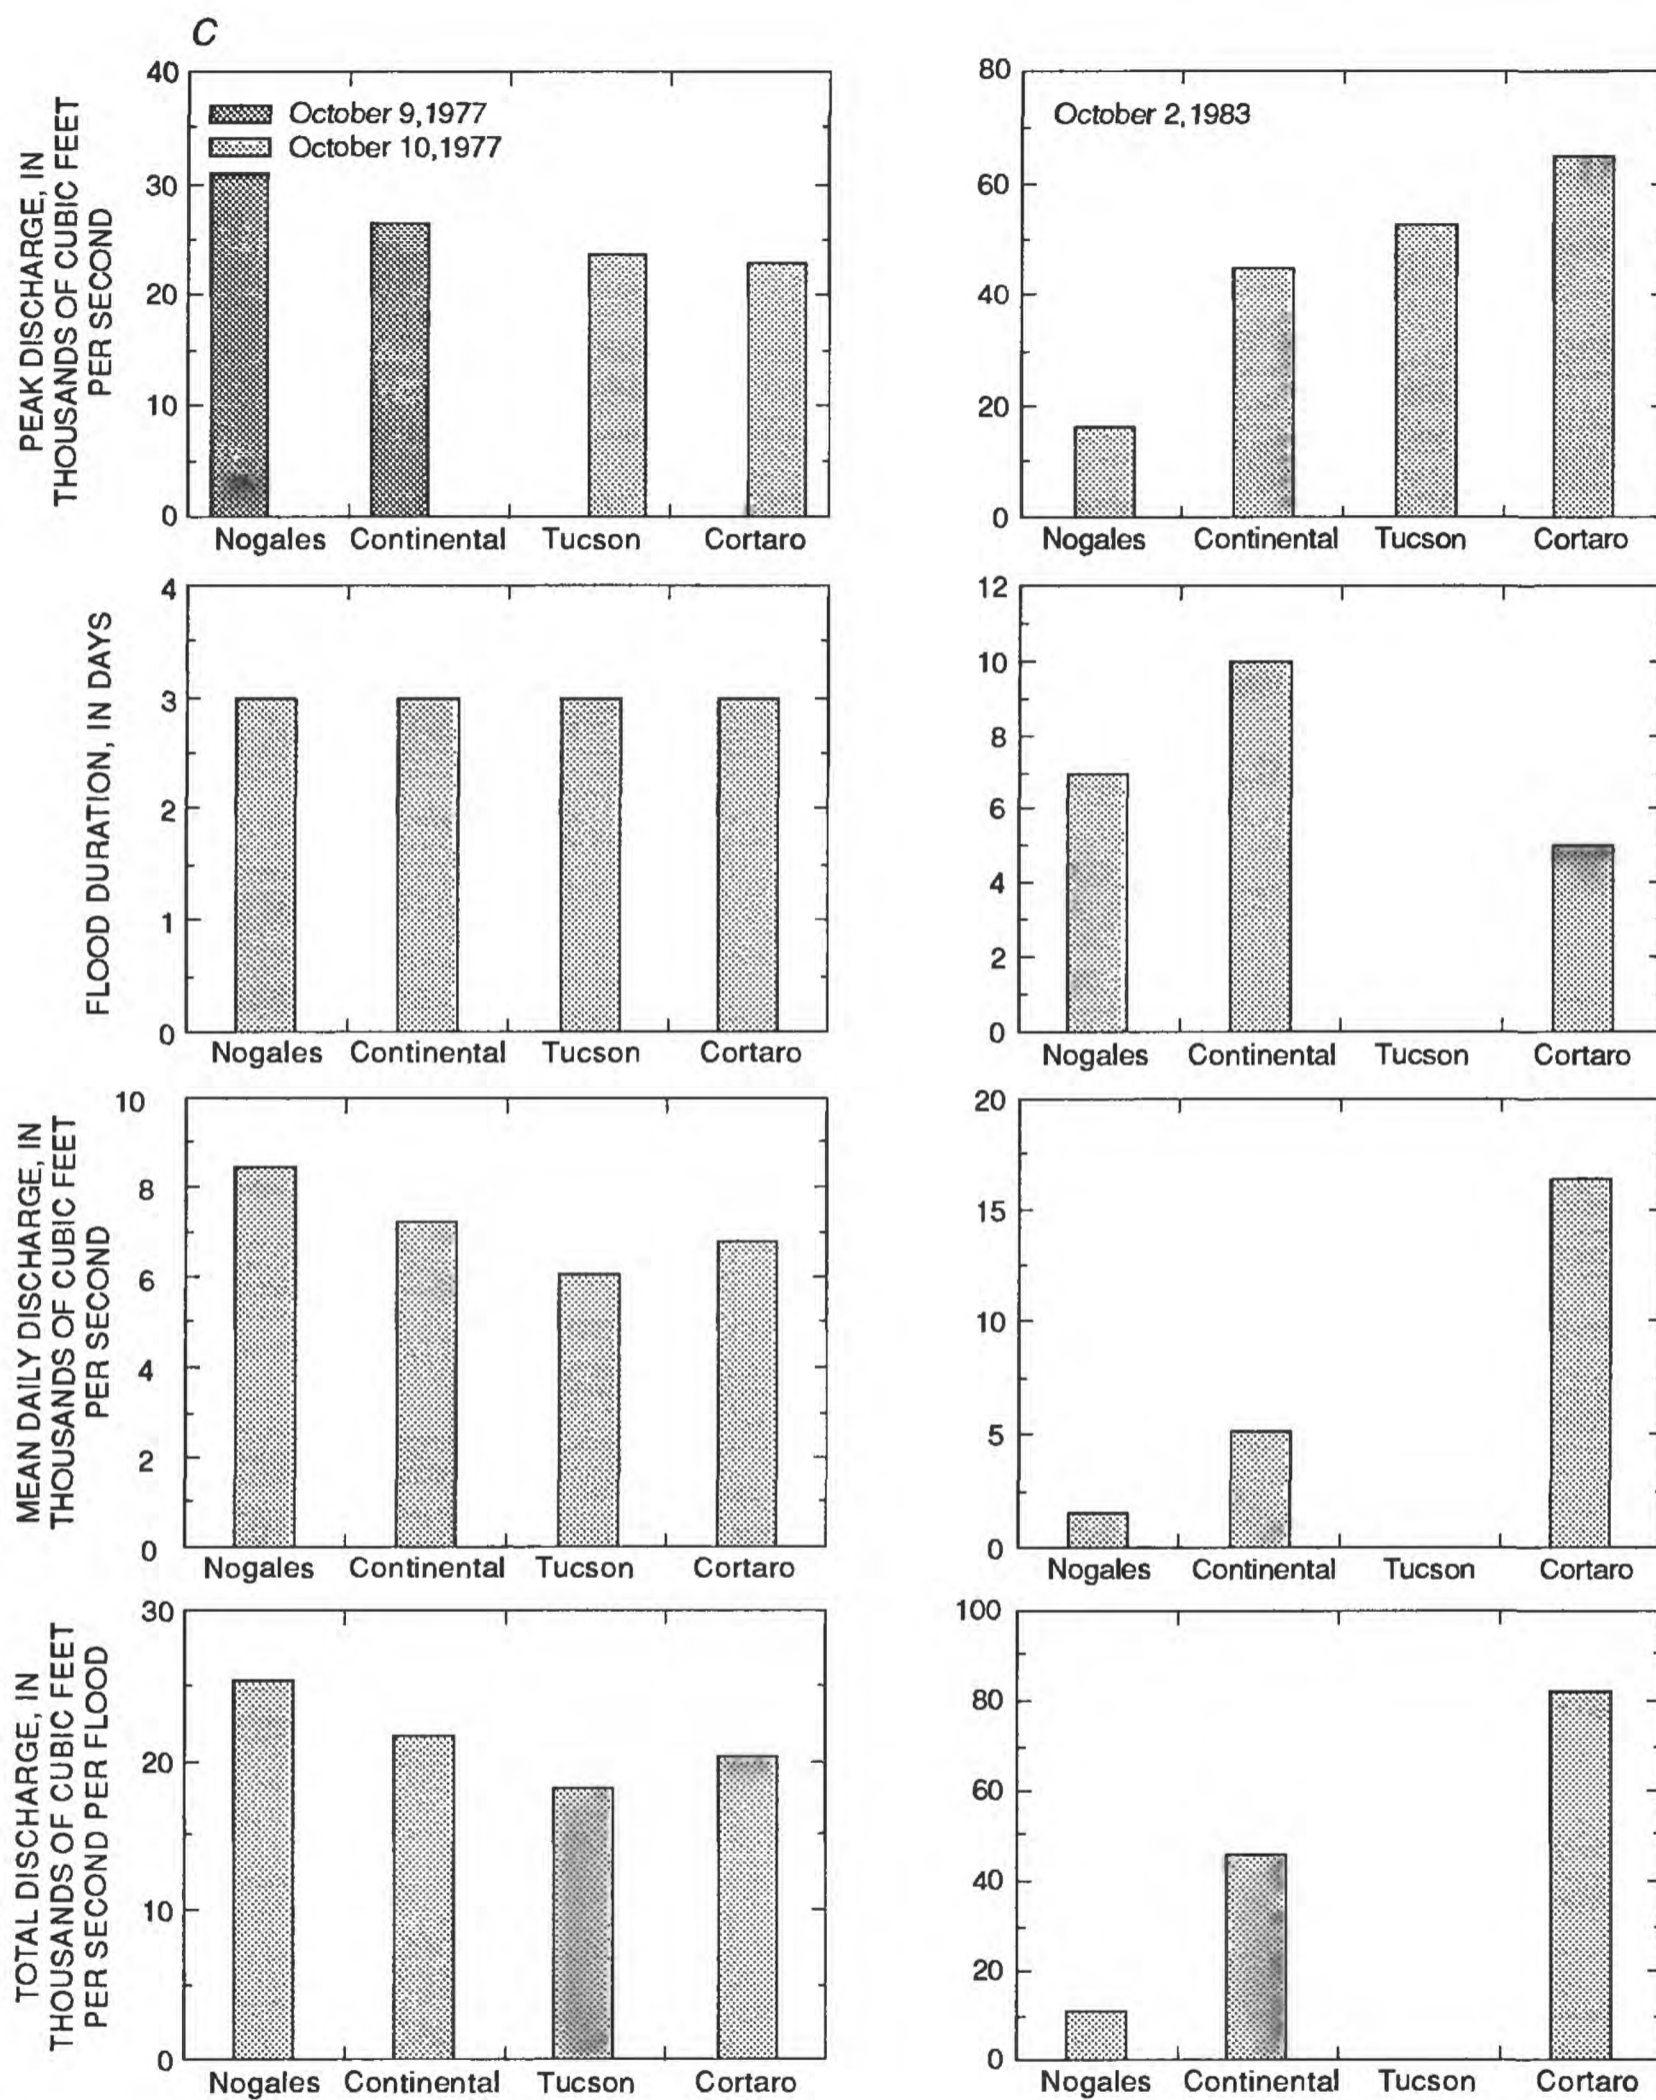
Figure 21. Flow characteristics of floods caused by different storm types at four stations on the Santa Cruz River. (Source: Data from Webb and Betancourt, 1992.) A, Floods of August 23, 1961 (no flow recorded at Nogales), and August 1–2, 1978, caused by monsoons. B, Floods of December 22–23, 1965, and December 18–19, 1978, caused by frontal storms. C, Floods of October 9–10, 1977, and October 2, 1983, caused by tropical storms. In 1983, the Tucson station was not in operation and peak discharge was determined indirectly.

The highly localized distribution of summer monsoonal precipitation is reflected in flood patterns of August 23, 1961, and August 1-2, 1978 (fig. 21A). The 1961 flood—the third largest of record at Tucson (table 5) and the eighth largest at Cortaro—produced a modest peak discharge at Continental and no flow at all at the Nogales streamflow-gaging station. Such a pattern is a product of the limited areal extent of intense precipitation during monsoonal thunderstorms. Spatial and temporal patterns of flow are more complex for the August 1978 flood. The timing and magnitude of peak discharge varied considerably among the four stations, and there was no direct relation between peak discharge and the other flow characteristics of duration and mean and total discharge (fig. 21A). Flow was considerably more flashy at Tucson where the flood lasted 1 day than at Nogales where the flood lasted 9 days but produced only twice the total flood volume. The variability among the four stations may reflect precipitation patterns but may be further influenced by different

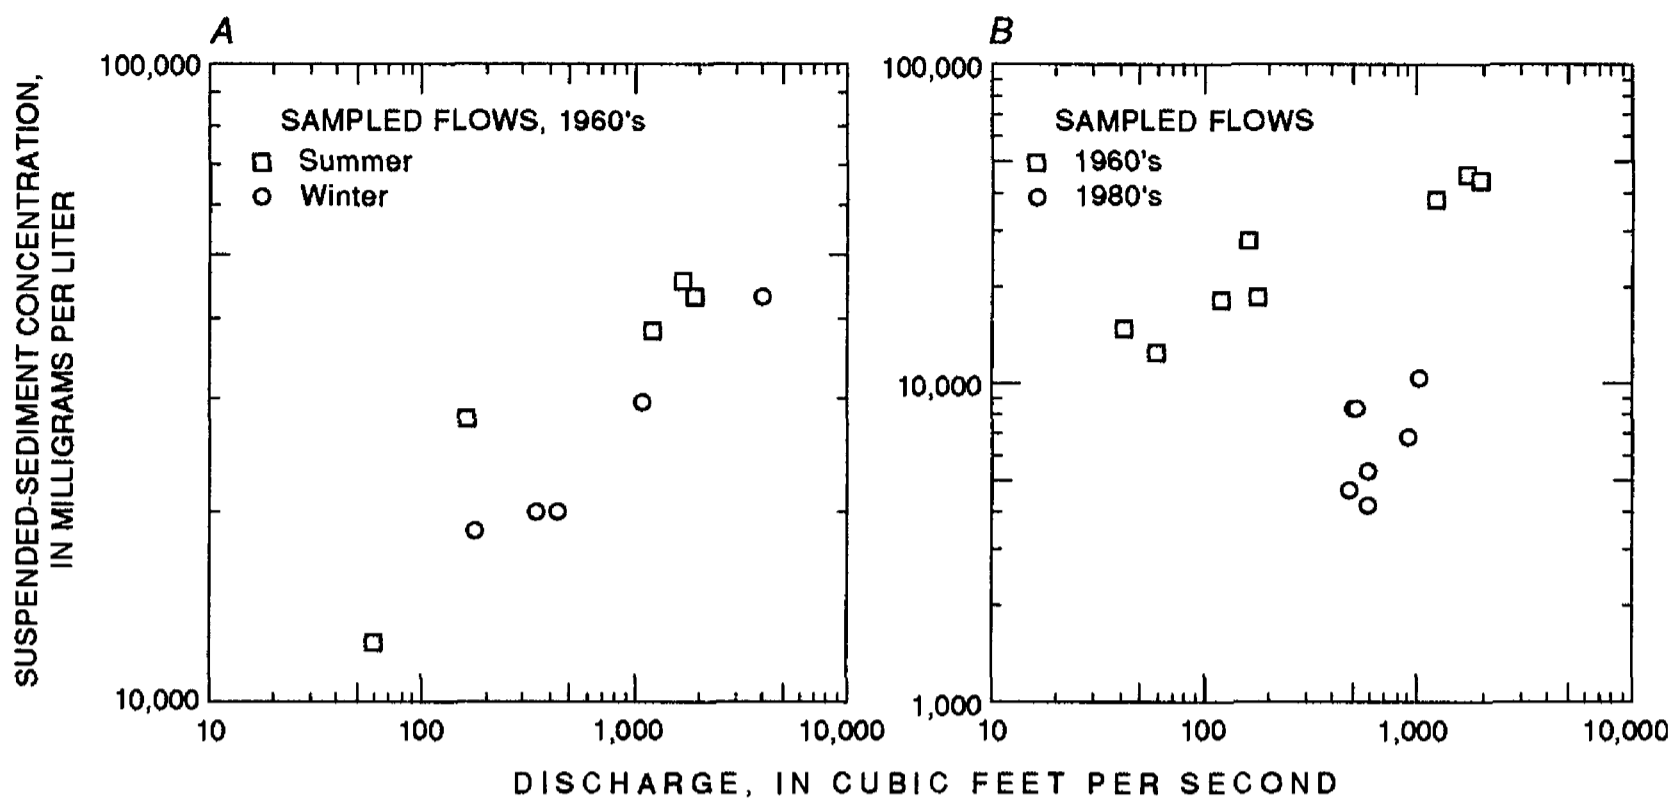
Figure 22. Relation of suspended-sediment concentration and discharge, Santa Cruz River at Tucson.

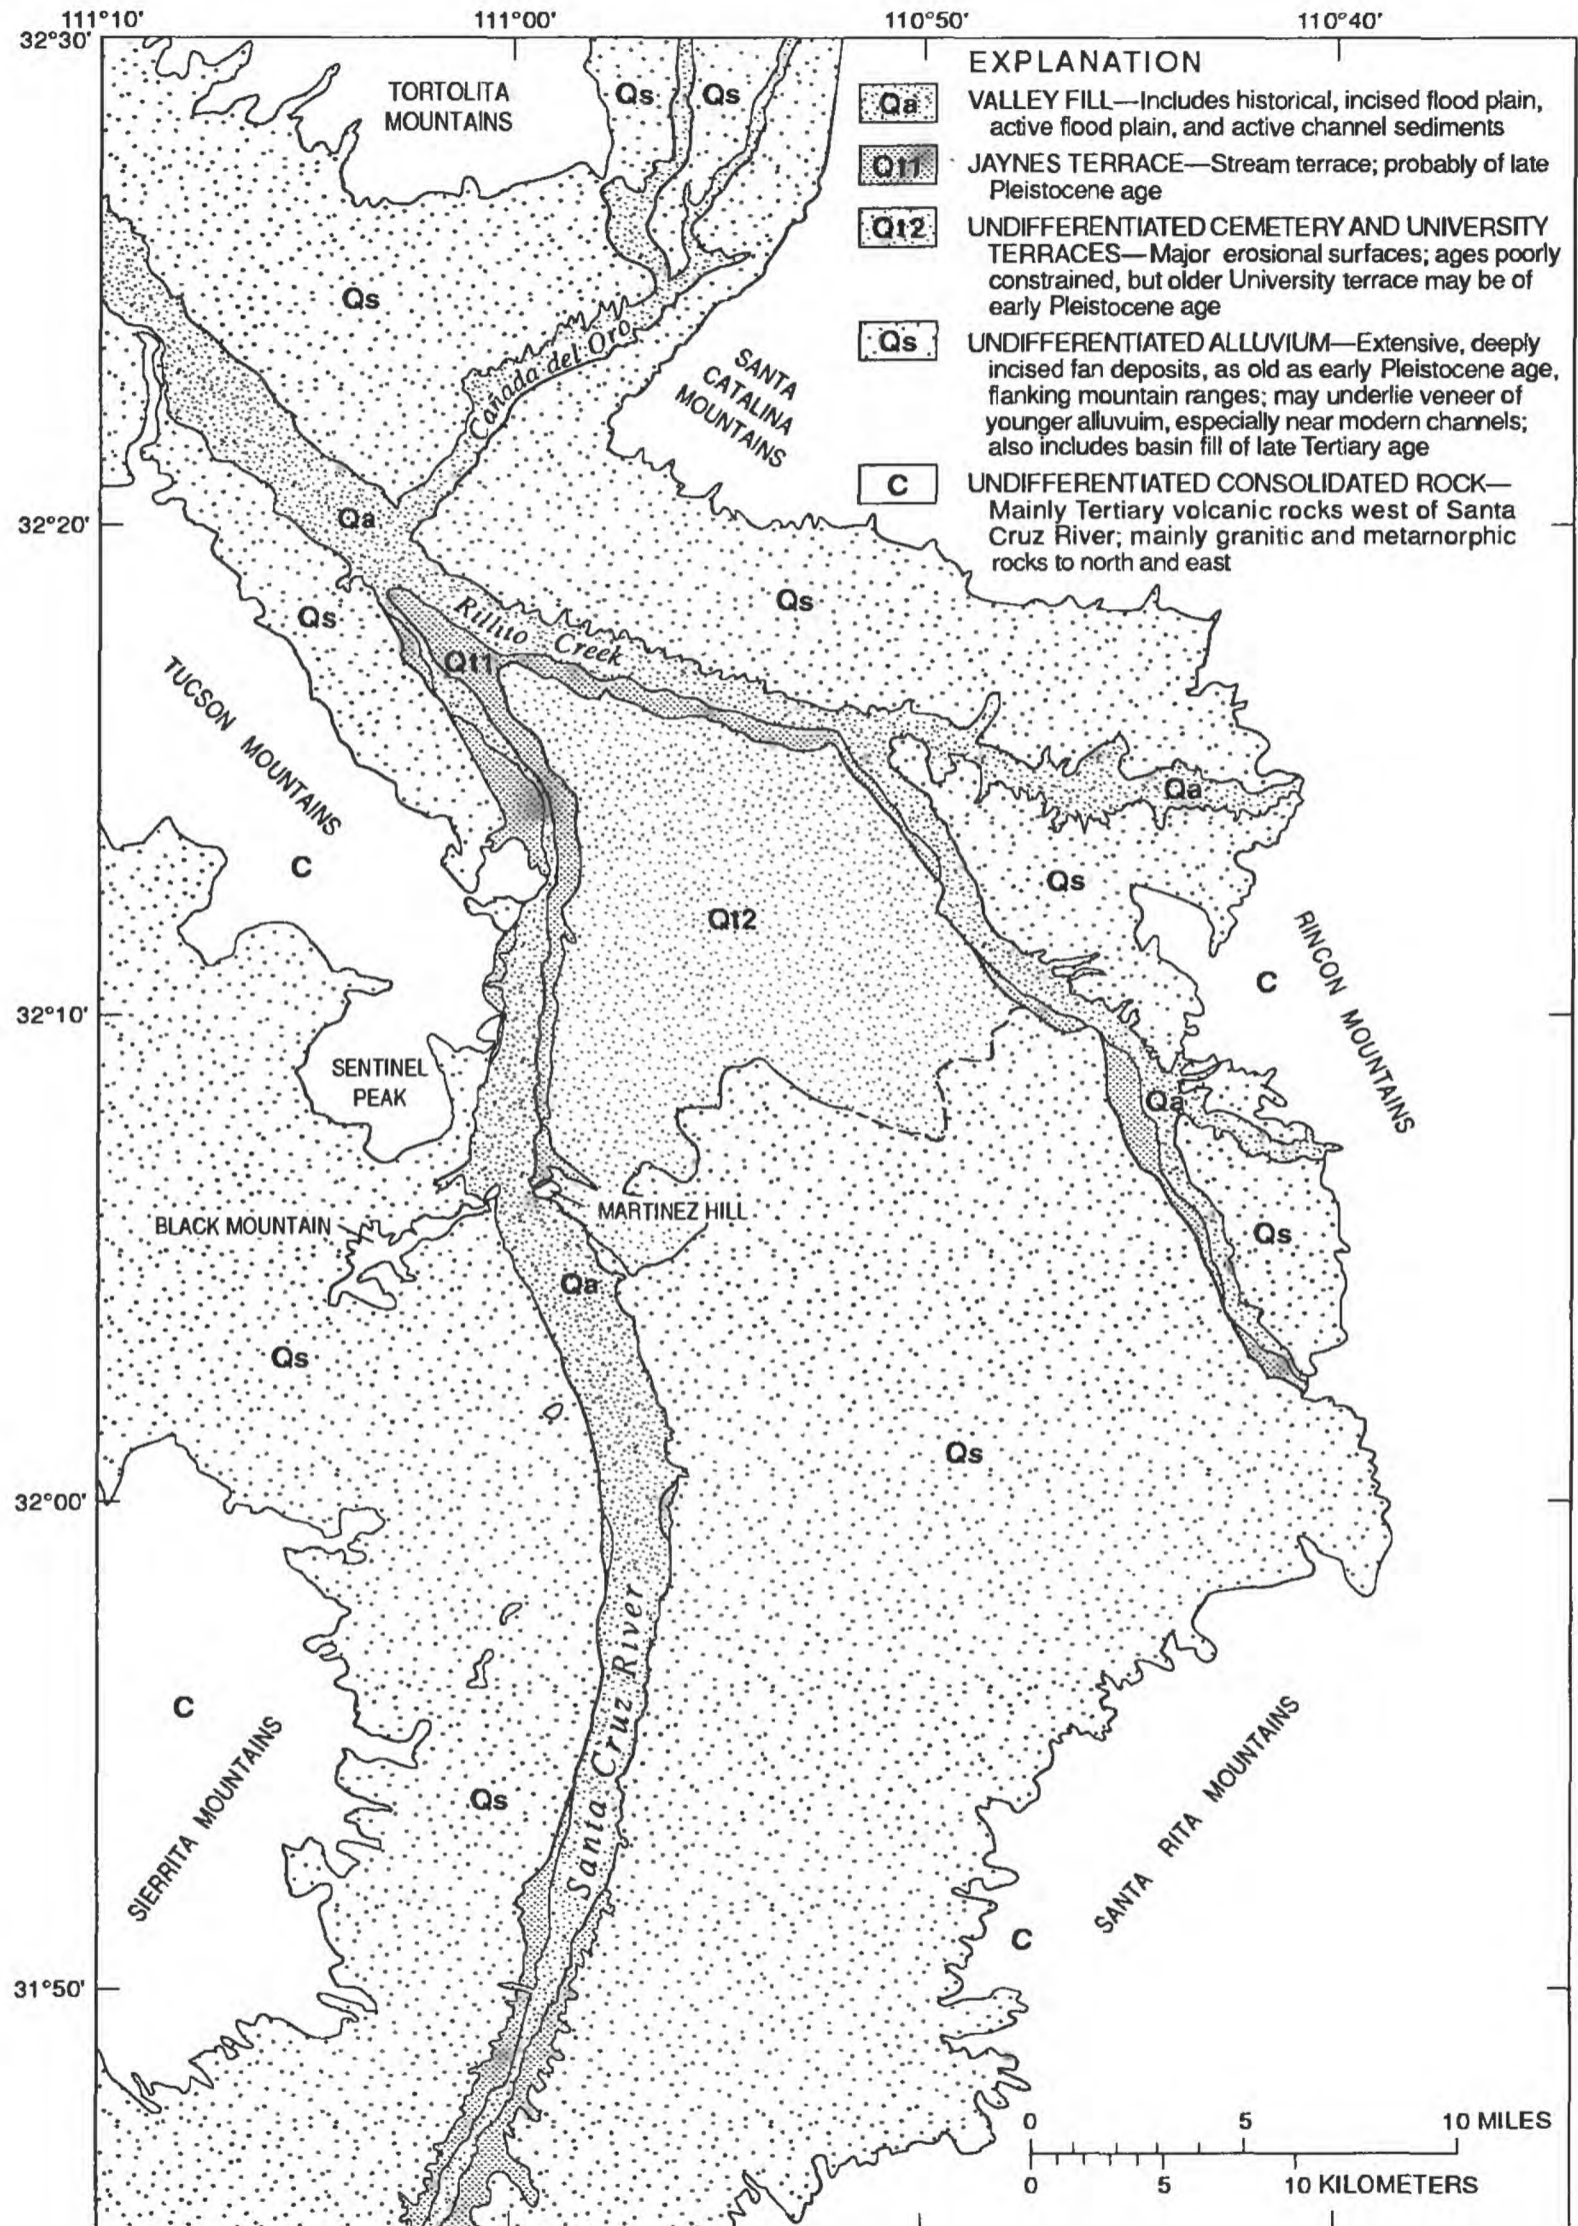
Figure 23. Geomorphology and surficial geology of the Tucson basin. (Source: Modified from Davidson, 1973; McKittrick, 1988; Jackson, 1989.)

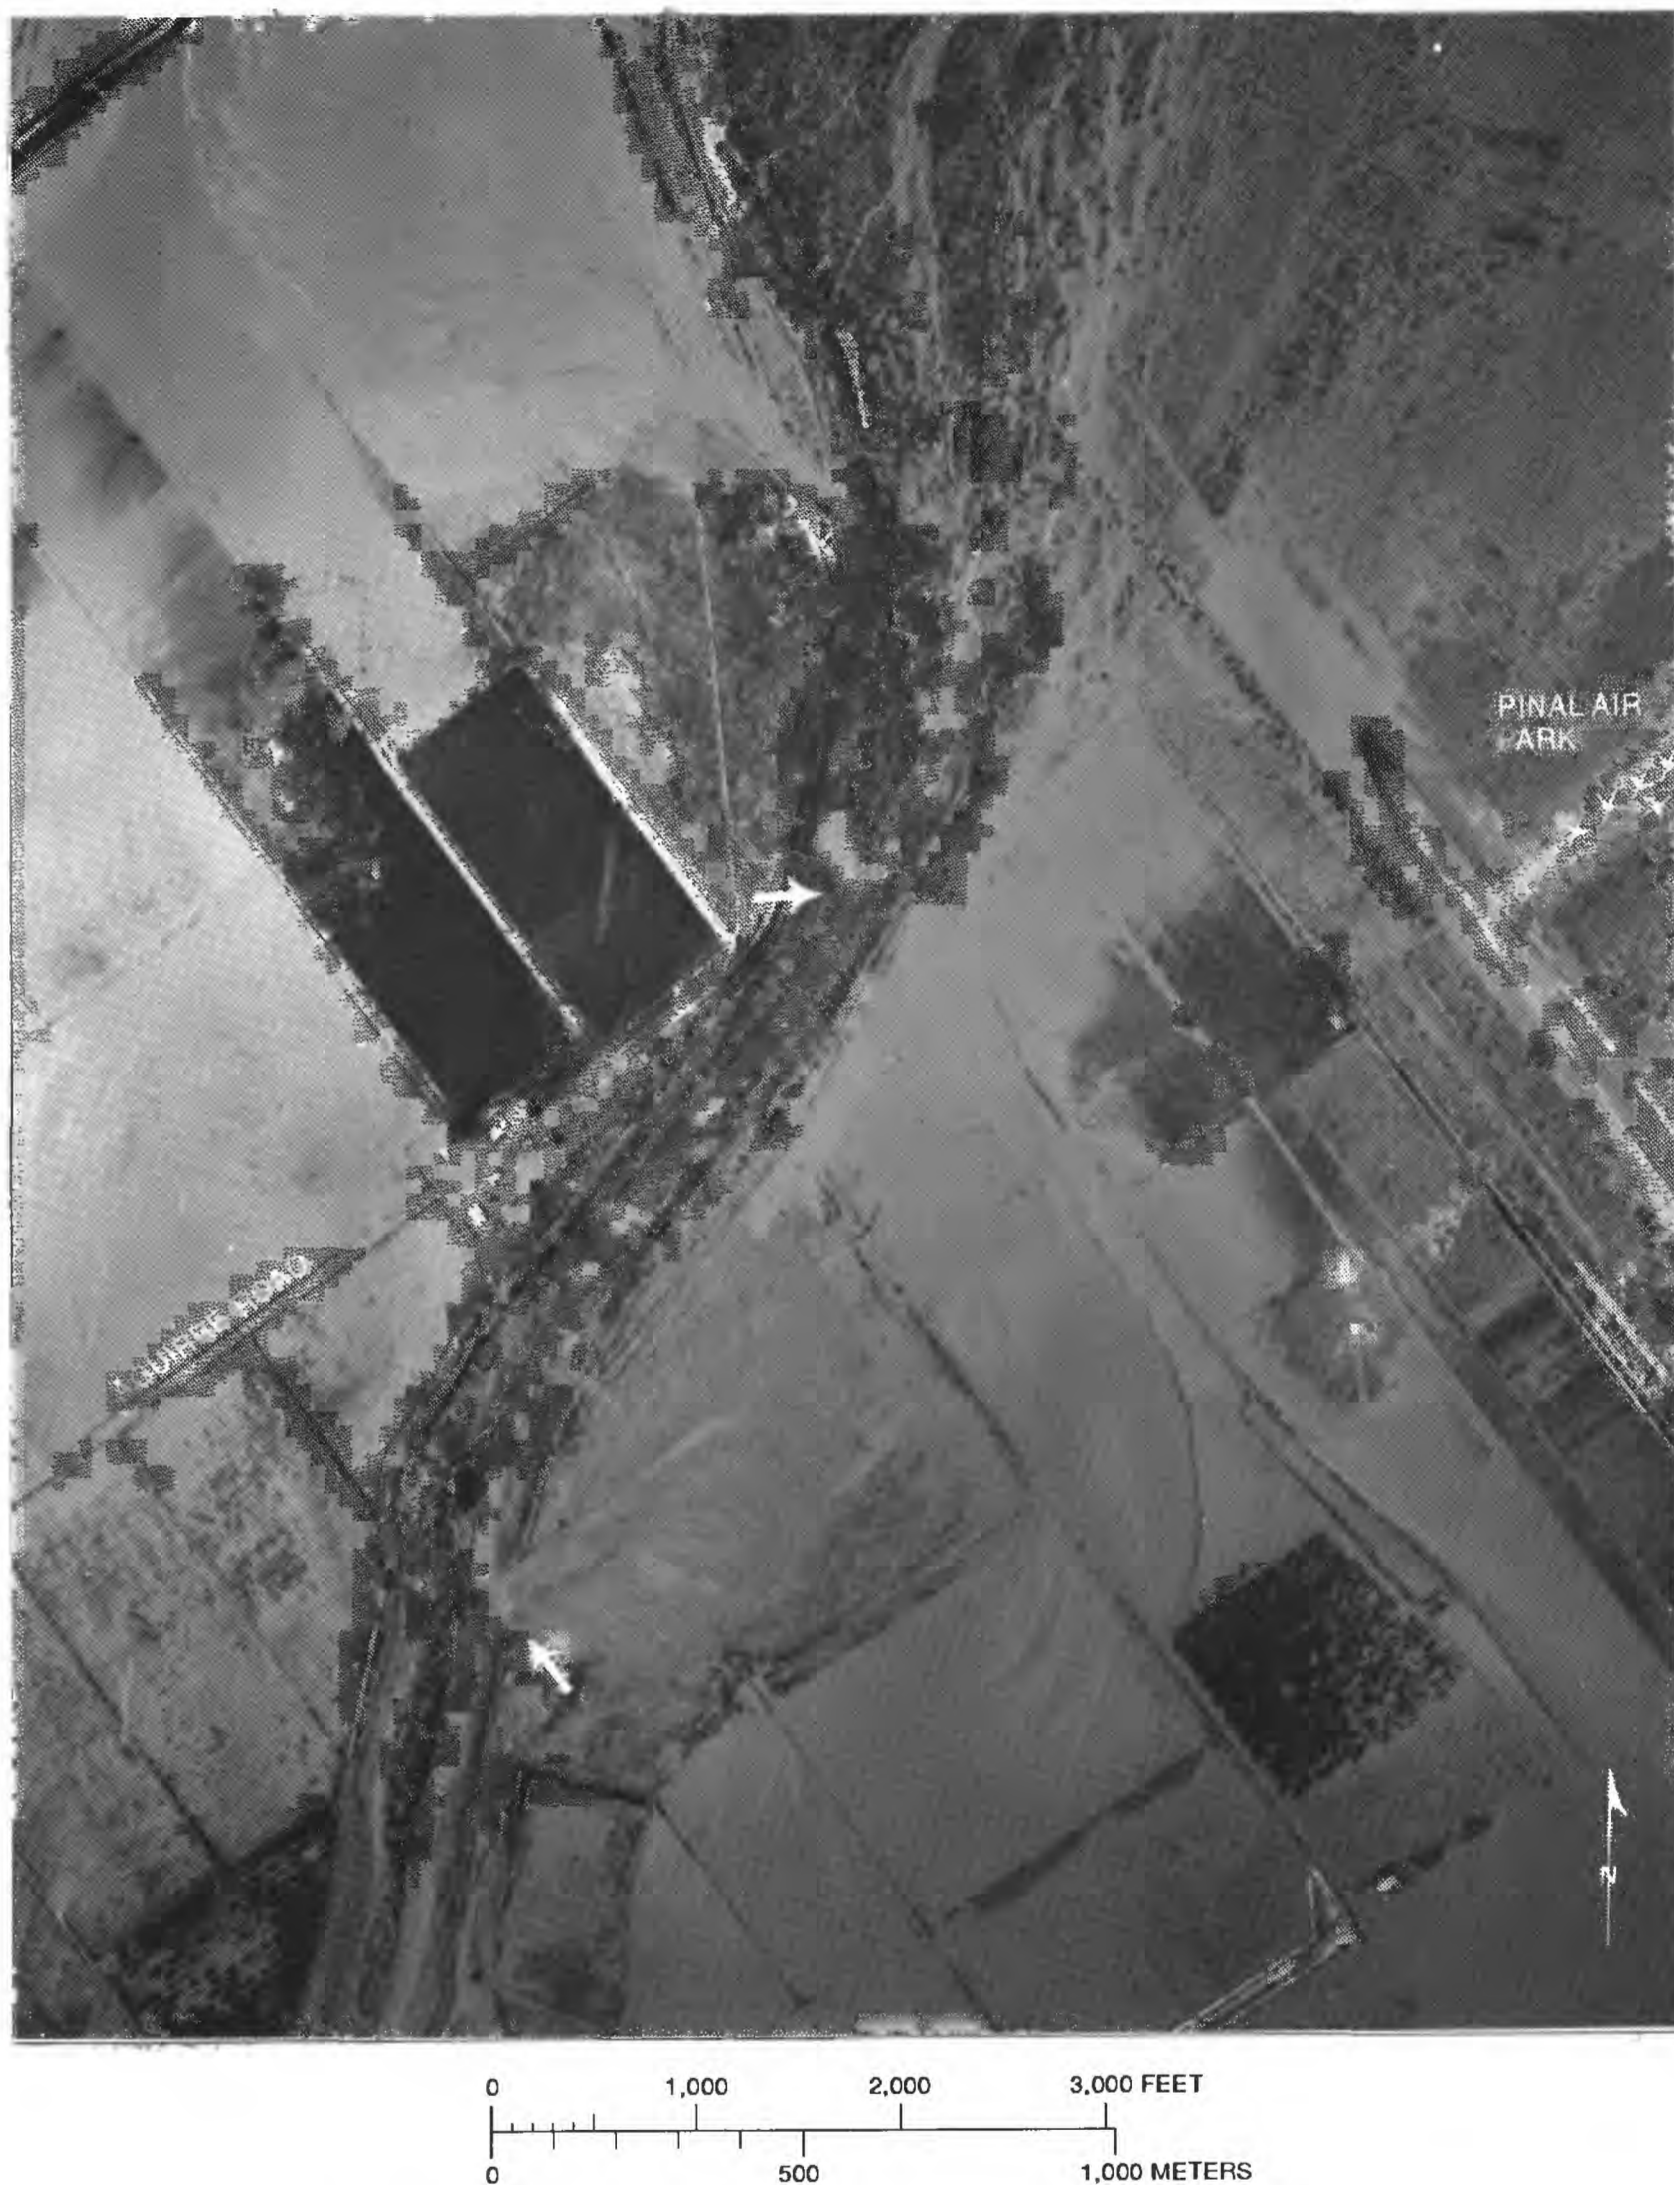
Figure 24. Floodwaters breaking through levees (indicated by arrows) on the lower Marana reach during the flood of October 1983. (Source: Cooper Aerial Survey, 1983.)
